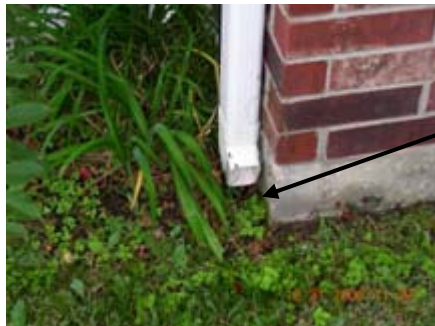
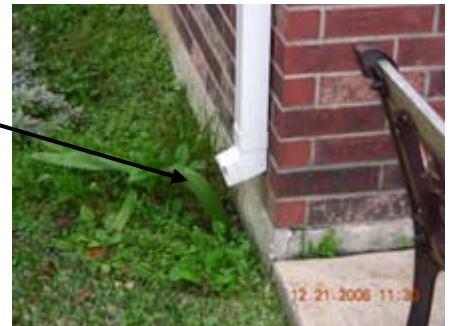
- The rear gutter drains should terminate further from the foundation to prevent excess water buildup around the foundation. At the very least, gutter pads should be installed to decrease the amount of erosion caused by runoff from the gutter drains.

Inadequate gutter terminations

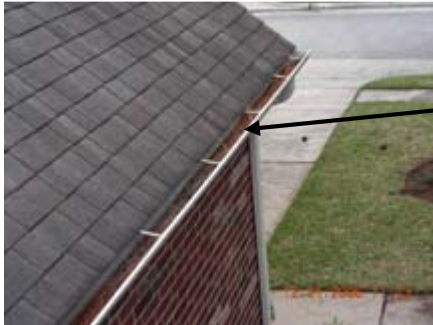
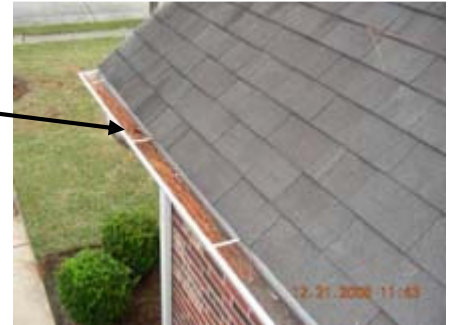
- The front gutters need to be cleaned to achieve maximum water capacity of water running off of the roof. Gutter cleaning will need to become a part of regular maintenance to prevent unnecessary damage to the gutters and fascia board.

Debris in gutter

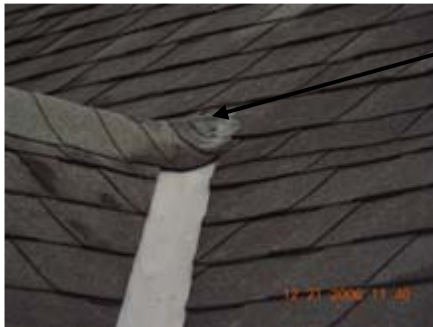
- Some of the shingles on the home are in need of repair. The areas in particular that were observed include the ridge cap at the front of the house that has a torn shingle and an area that needs re-tarring, and the ridge cap shingles over the roof saddle near the chimney. Although no evidence of water leaks were observed at the time of the inspection, it is recommended that these shingles get repaired/replaced to prevent any future water leaks.

Roof ridge needing tar

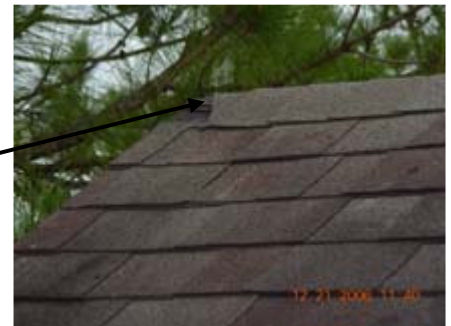
Torn shingle on roof ridge

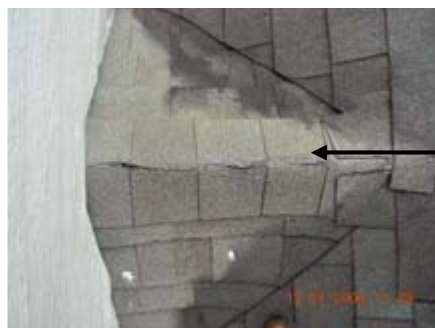
Ridge cap shingles near chimney in need of replacement

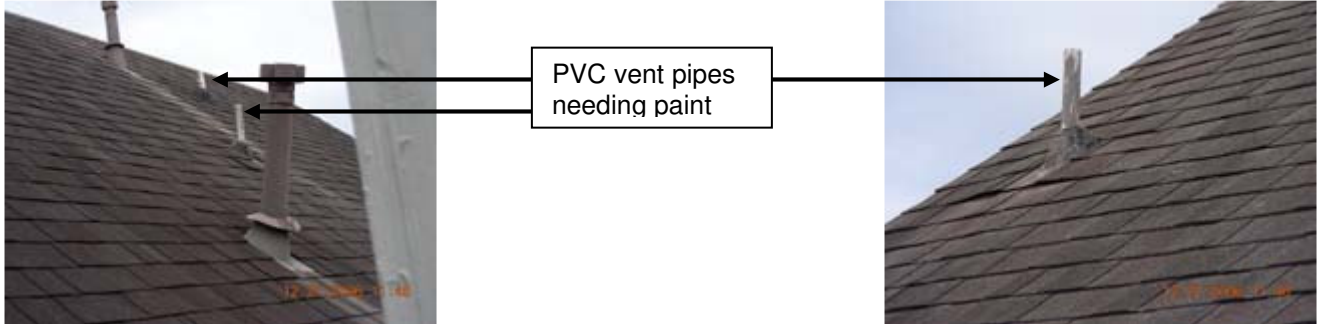
- The PVC exhaust vent pipes need to be painted better to prevent any premature deterioration from the sun's ultraviolet rays.

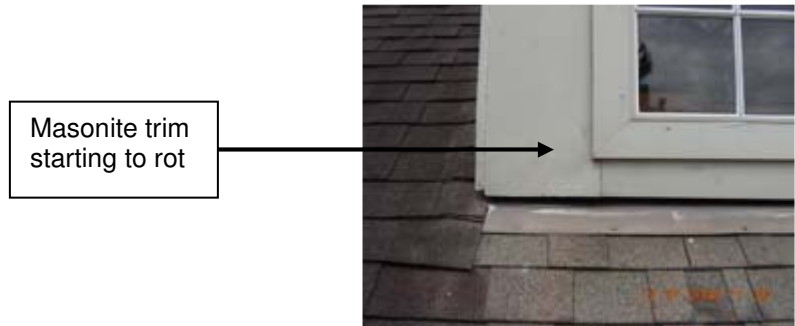
- The masonite siding and trim around the roof dormer is starting to rot. This siding ought to get repaired to prevent any future water damage to the structure.

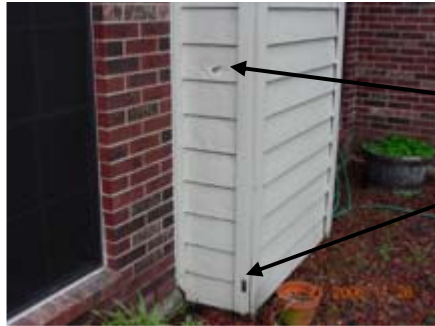
- The exterior walls covered with masonite siding are starting to deteriorate in some areas. The chimney masonite siding is in need of repair, as most of its siding is starting to deteriorate.

Deteriorating siding at chimney

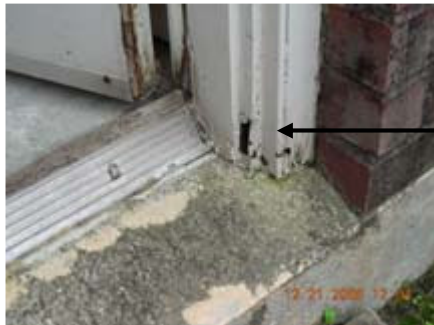
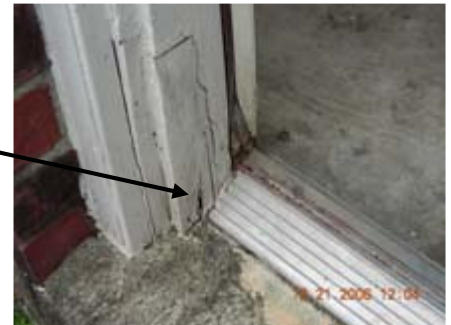
Rotted exterior door trim at garage door

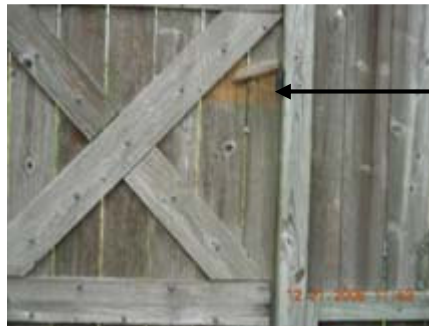
- The fence has boards in various locations that need replacement. The fence gate hardware on the driveway side of the house needs repair and the other gate drags across the ground when opened.

Broken gate latch

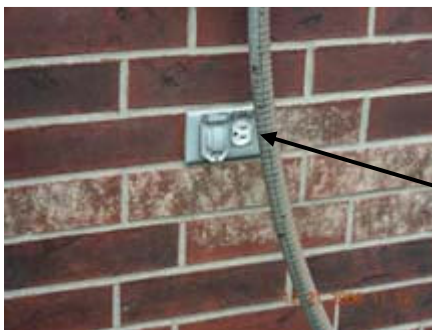
Front Exterior outlet with clogged ground slot

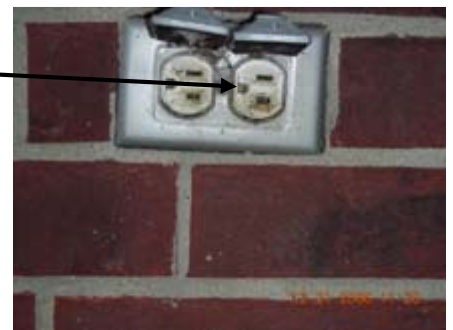
Exterior out near A/C missing weathertight cover

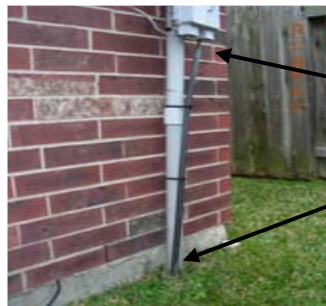
- The telephone wire conduit is broken and not secured to the service box, leaving the wires exposed to the weather and possible damage from items like weed trimmers and lawn mowers.

Broken conduit at telephone service panel leaving exposed wires

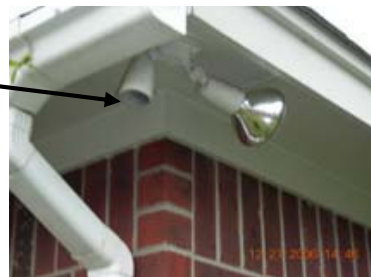
- There is a broken bulb in the rear flood lamp that needs to get removed before another bulb can be screwed into the socket.

Broken bulb in lamp socket

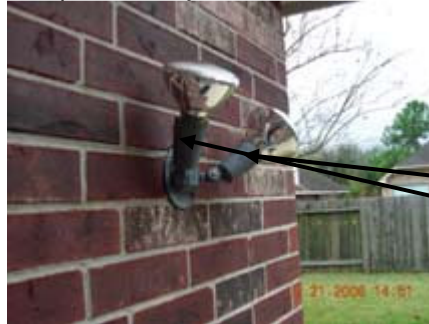
- The exterior flood lamp near the rear door should get angled down to prevent any water and debris from collecting in the lamp sockets.

Flood lamps inappropriately angled upward

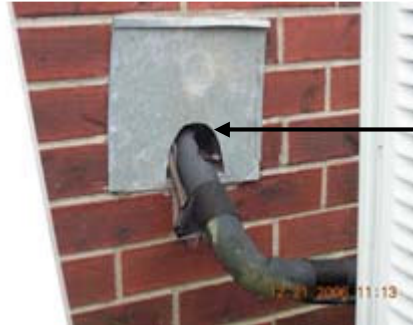
- More sealant is needed at the exterior wall where the air conditioner refrigerant lines enter the home to prevent moisture and rodent/pest intrusions.

Refrigerant line entry point requiring sealant

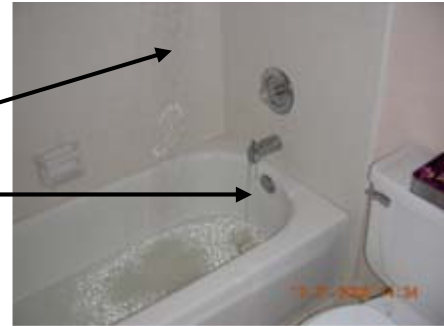
- The bathtub faucet in the guest bathroom continues to have water flow while the shower is running. The shower diverter valve should be replaced/repared to prevent unnecessary water usage.

Shower and faucet running at the same time

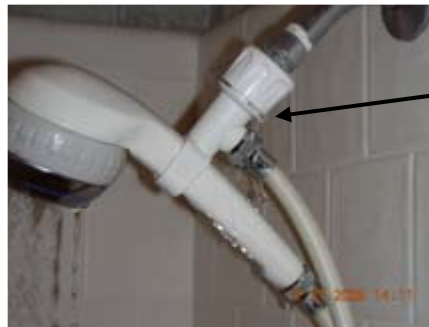
- The showerhead in the master bathroom has a leak where the showerhead connects to the water supply pipe.

Showerhead leak at connection to water supply pipe

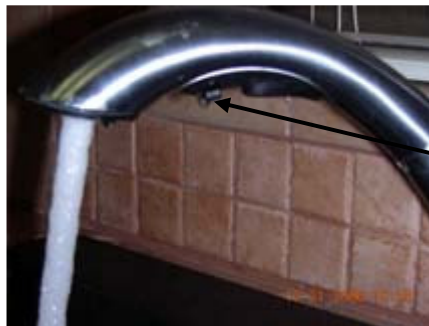
- The kitchen faucet has a leak at the control button that switches the water stream from the faucet pattern to the spray pattern.

Leak at kitchen faucet control button

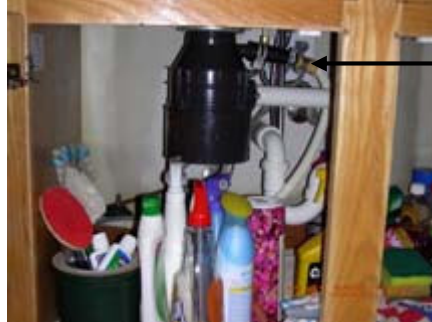
- The dishwasher drain line should have an anti – siphon loop to prevent any backflow from the sink into the dishwasher.

Dishwasher drain line should loop and enter the cabinet higher to prevent backflow from the sink drain line into the dishwasher

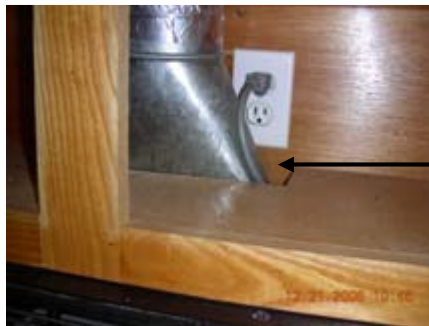
- The range hood is an exterior exhaust type, built into the microwave. The range hood fan works properly, but the light did not turn on (a new bulb was not tested). The filters will have to be changed/cleaned as needed, depending on use.
- The range hood exhaust duct is not properly sealed to the exhaust port of the hood; therefore, all cooking fumes cannot be properly exhausted to the outside.

Exhaust leak around exhaust duct due to improper seal at exhaust port

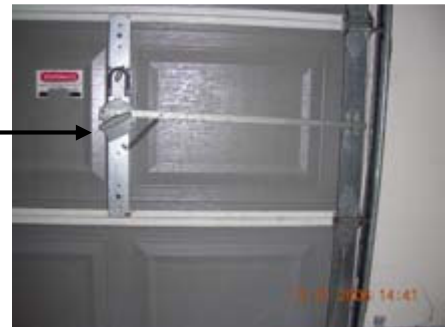
- The garage door opener photoelectric eye properly reverses the operation of the door when the beam is broken. However, the auto reverse function of the opener needs to be adjusted to reverse the door when the motor senses an obstruction that is preventing the door from closing.
- The garage door manual locking mechanism is not disabled. If the automatic opener is used while this lock is engaged, significant damage can be done to the garage door. It is recommended that the manual lock get removed or disabled.

Manual locking mechanism needs to be disabled

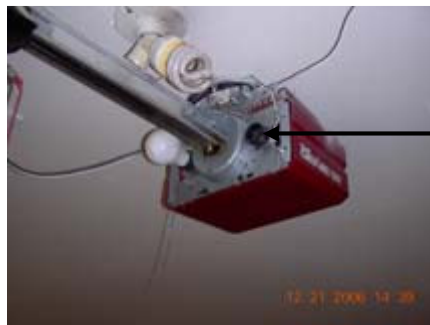
- The garage door operator is missing a light bulb and the cover that protects the light bulb from damage.

Garage door operator missing light bulb and cover
